TECHNICAL INSPECTION REPORT

U.S.S. SEARAVEN (SS196)

TEST BAKER

OPERATION CROSSROADS

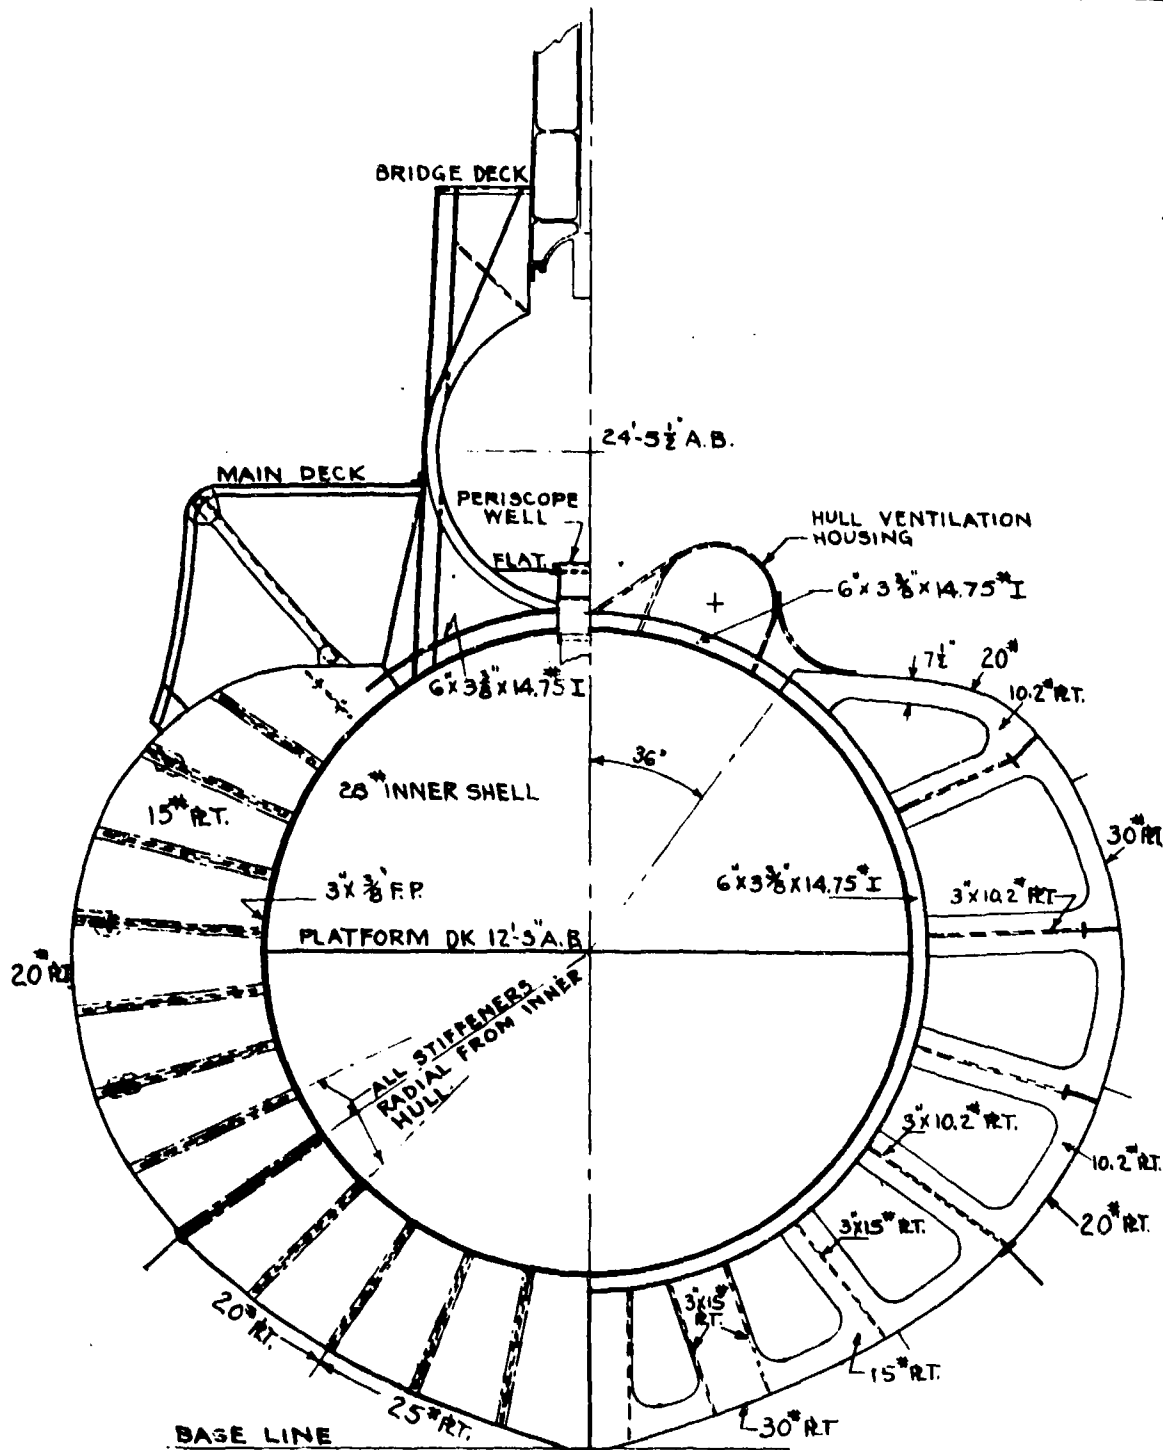
FRAME 71
LOOKING FORD.
SUPERSTRUCTURE SHOWN
AT FR. 74
SECRET

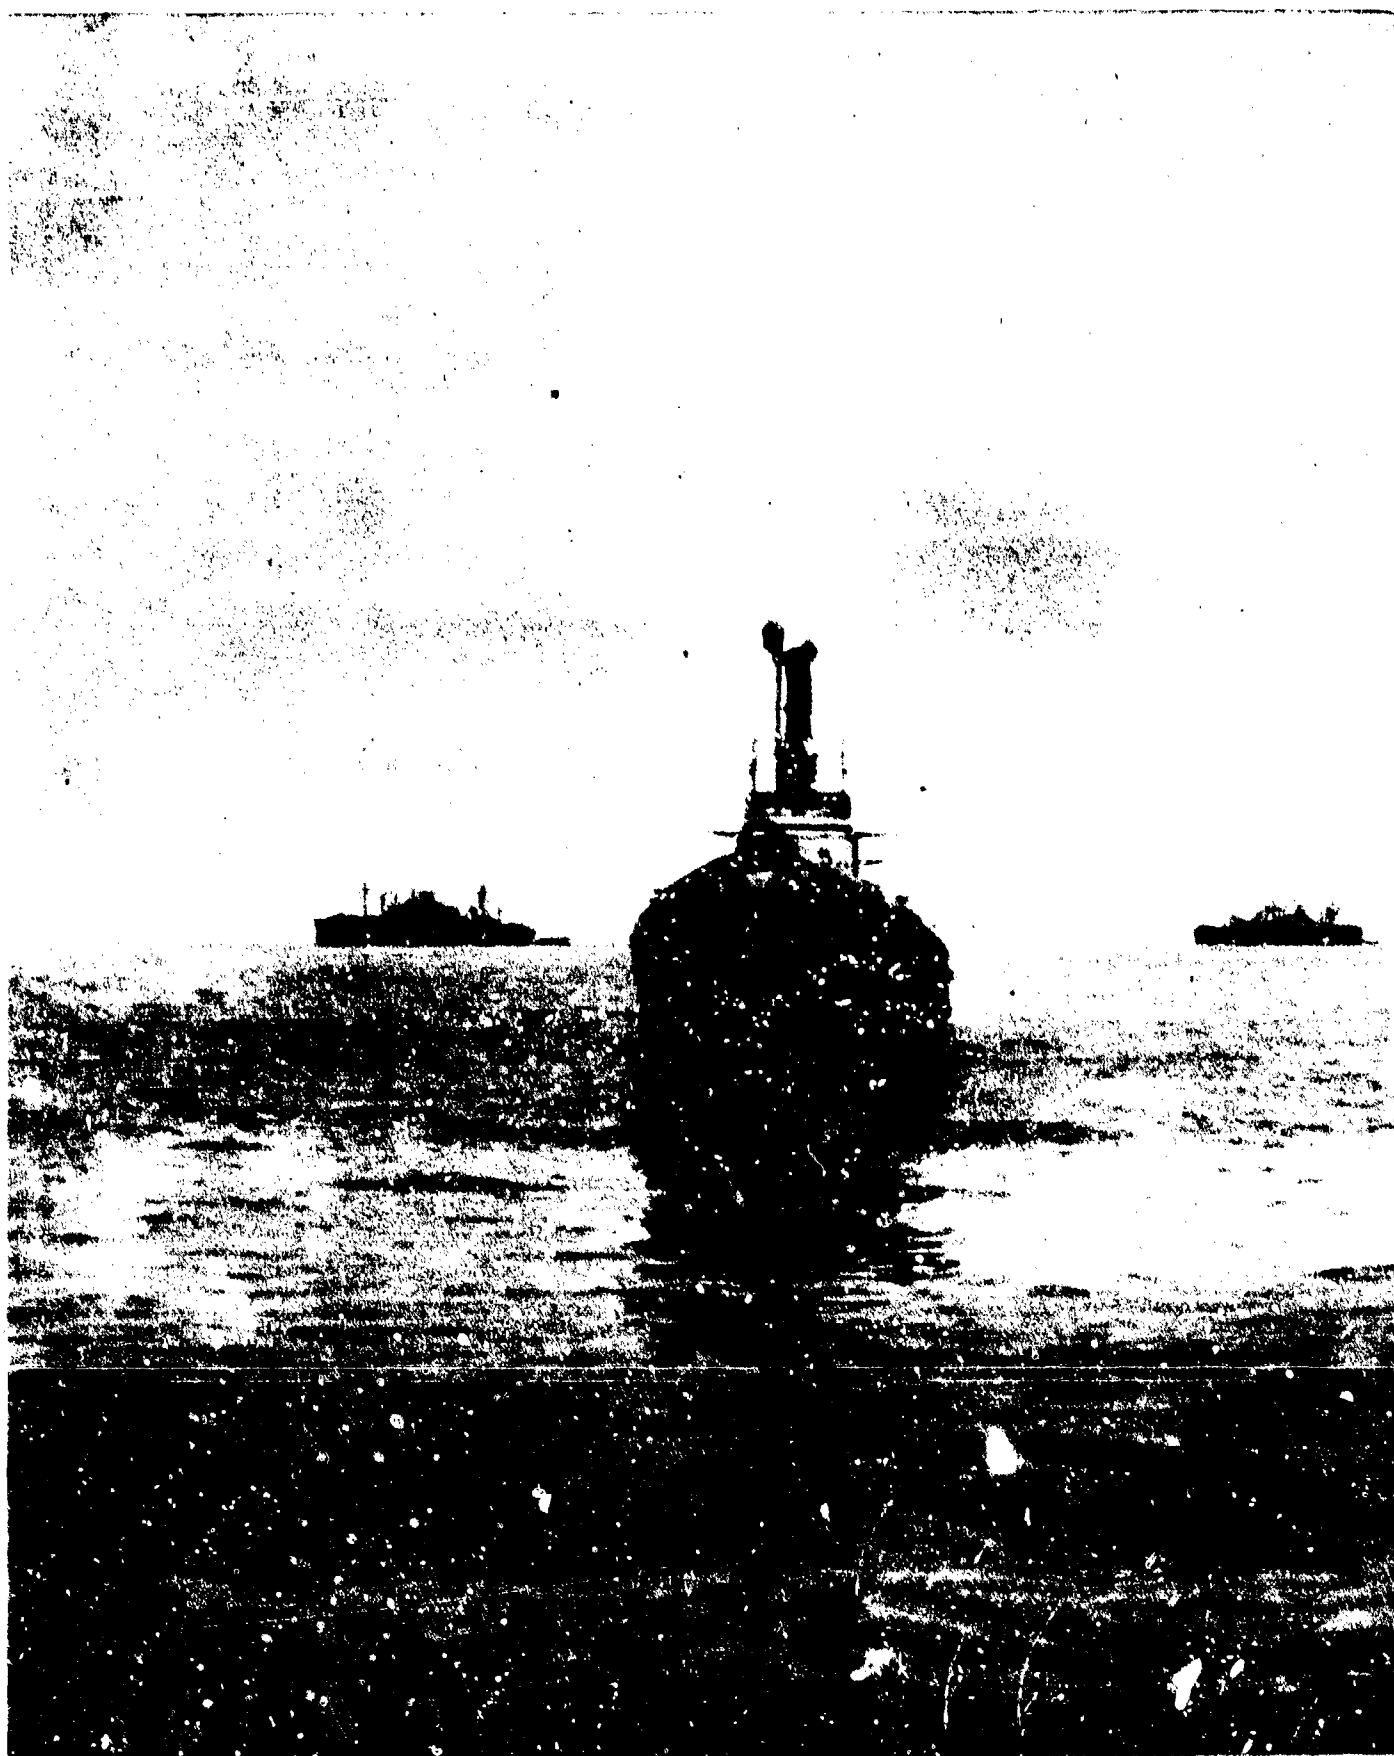
AB-CR-227-283-2: General view from ahead.

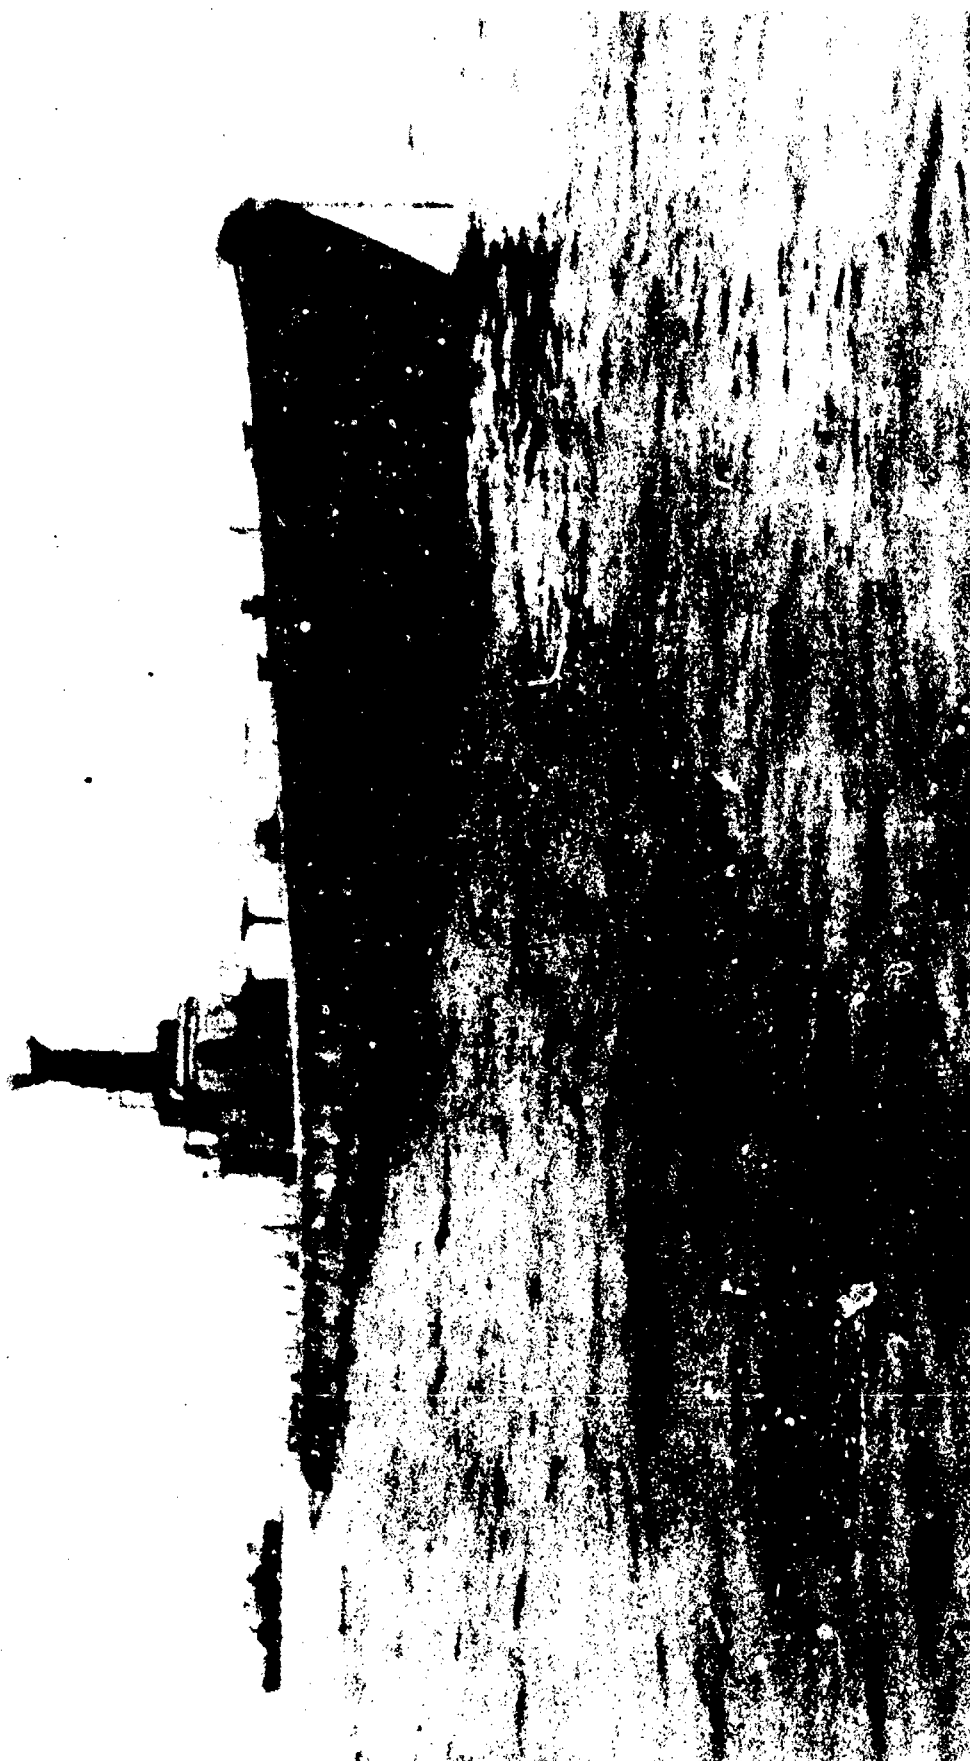
AB-CR-227-283-1: General view from starboard bow.

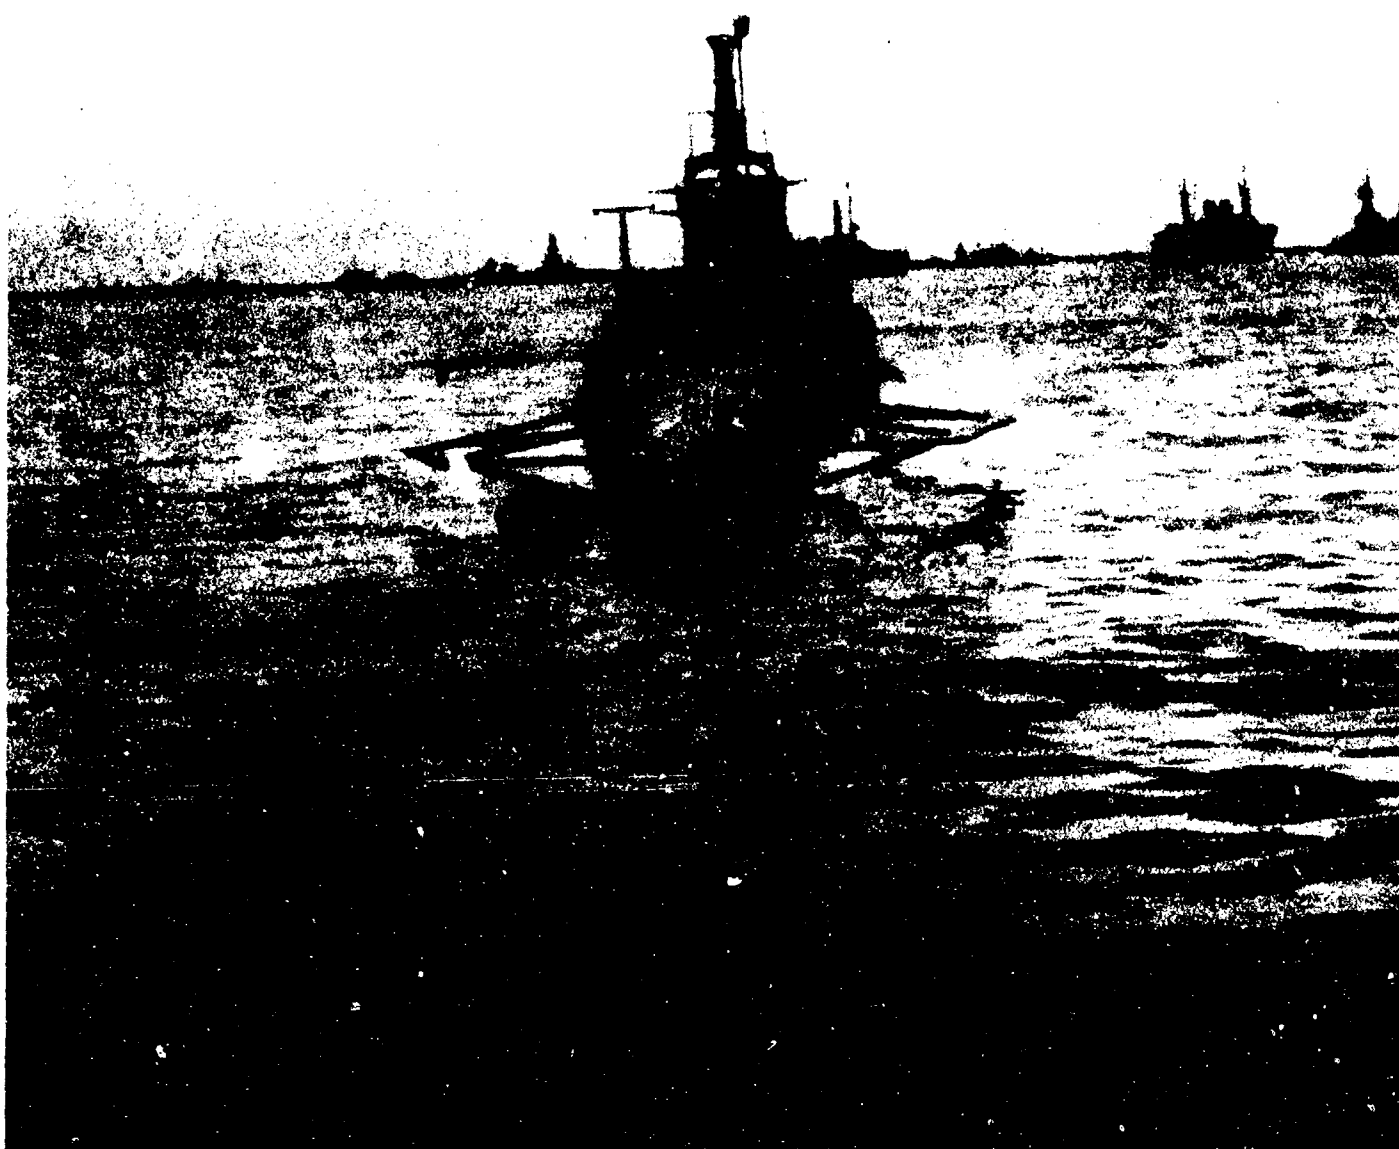
AB-CR-227-283-6; General view from astern.

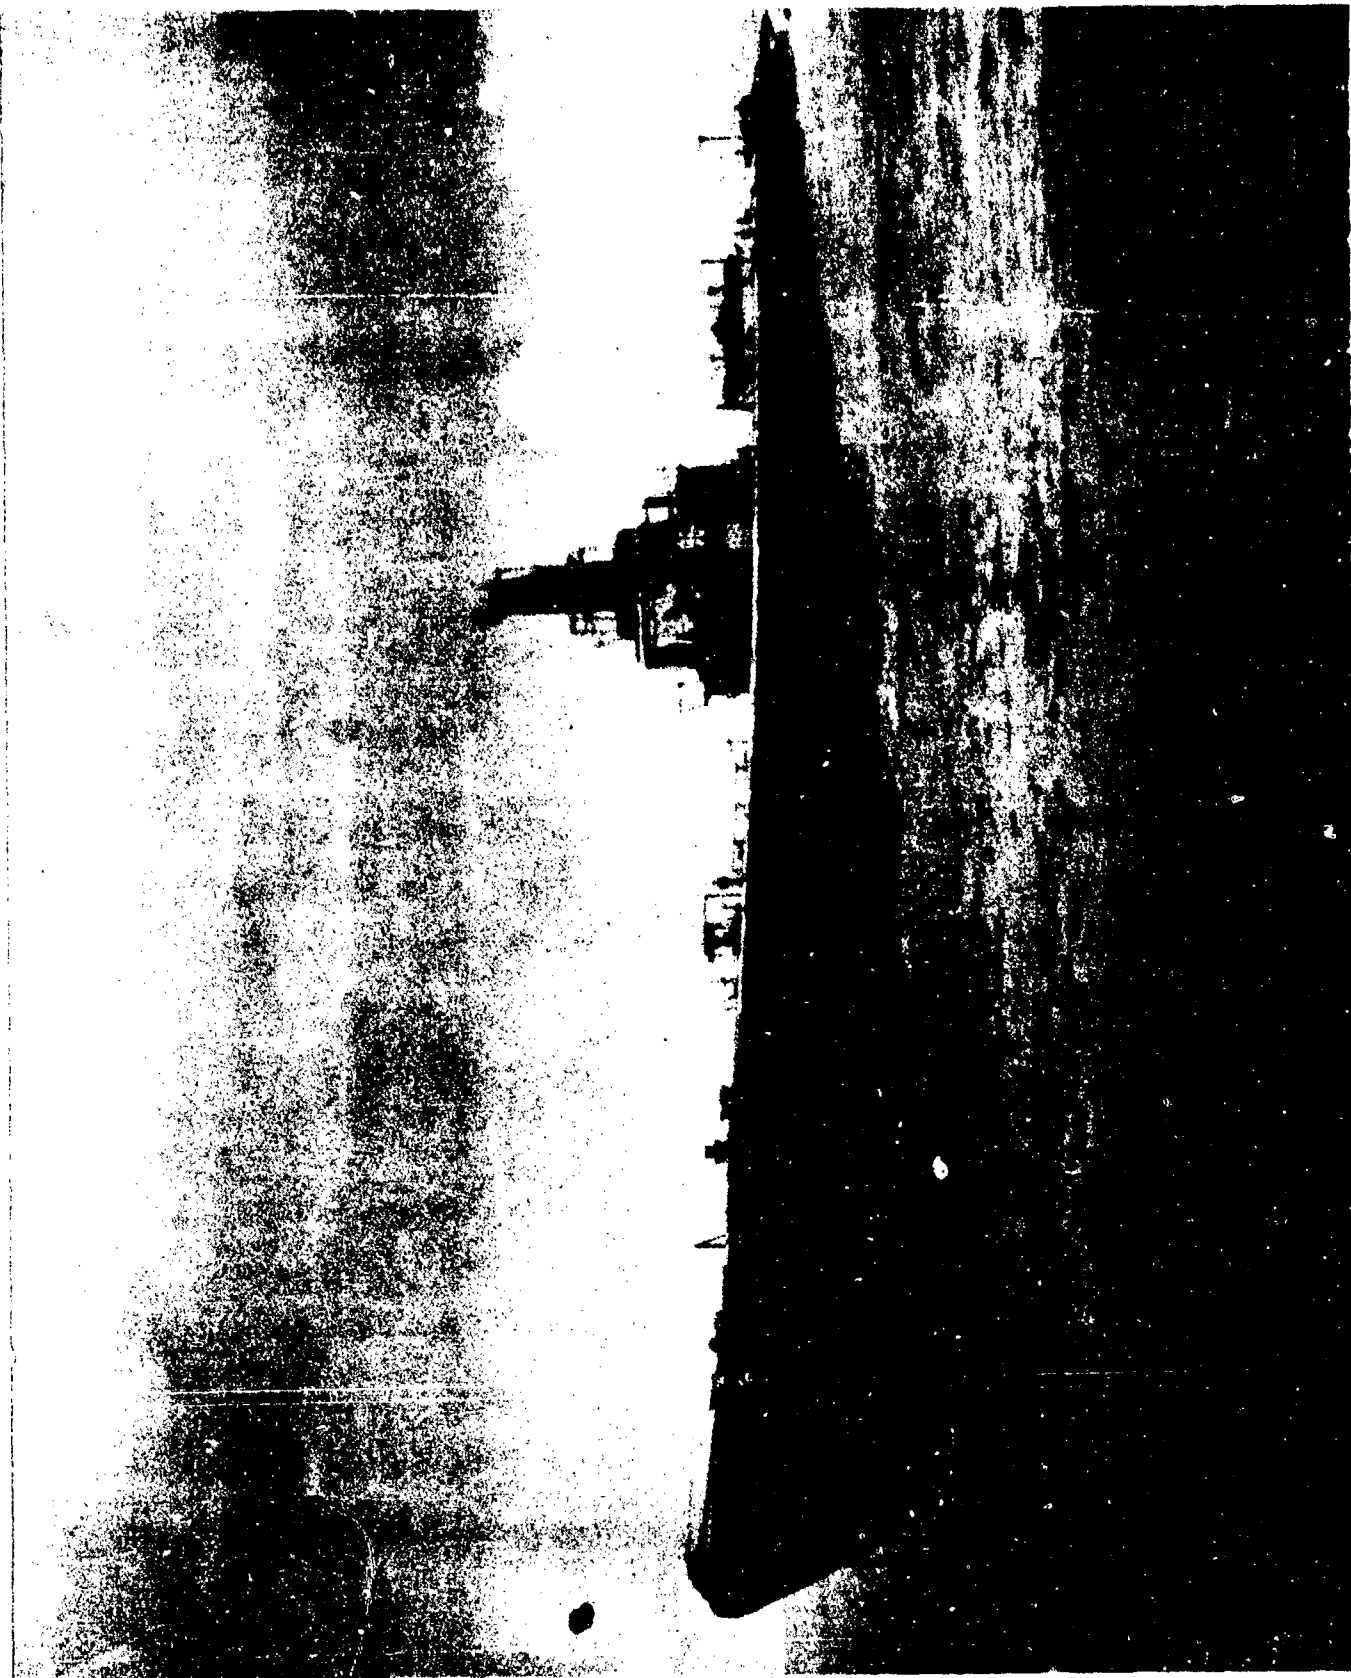
AB-CR-227-283-3: General view from port bow.
